DEPARTMENT OF TRANSPORTATION**DIVISION OF ENGINEERING SERVICES**

Contract #: 04-0120F4Cty: SF/ALA Rte: 80 PM: 13.2/13.9File #: 69.28**WELDING INSPECTION REPORT****Resident Engineer:**Pursell, Gary**Address:** 333 Burma Road**City:** Oakland, CA 94607**Report No:** WIR-003040**Date Inspected:** 15-Jun-2008**Project Name:** SAS Superstructure**OSM Arrival Time:** 2200**Prime Contractor:** American Bridge/Fluor Enterprises, a JV**OSM Departure Time:** 700**Contractor:** Zhenhua Port Machinery Company, Ltd (ZPMC), Changxing Island **Location:** Shanghai China**CWI Name:** Chen Xi**CWI Present:** Yes No**Inspected CWI report:** Yes No N/A**Rod Oven in Use:** Yes No N/A**Electrode to specification:** Yes No N/A**Weld Procedures Followed:** Yes No N/A**Qualified Welders:** Yes No N/A**Verified Joint Fit-up:** Yes No N/A**Approved Drawings:** Yes No N/A**Approved WPS:** Yes No N/A**Delayed / Cancelled:** Yes No N/A**Bridge No:** 34-0006**Component:** Deck panels & PMT**Summary of Items Observed:**

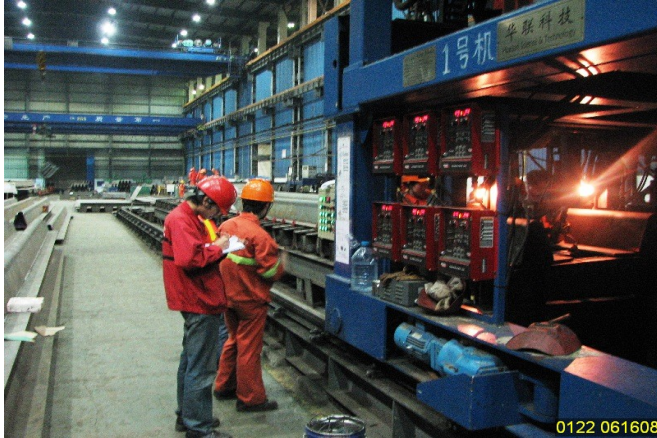
Item	Description	WBS	Dwg No.	Status
1	Picture above left Typical, CWI Chen Xi monitoring welding head parameters for a PMT on Gantry#1.			
2	Picture above right Typical, ZPMC UT technician Xue Hai Vang calibrating the UT instrument for PJP welds on the PMT.
